## Preventive and Corrective Diagnosis of the Built Infrastructure, Faculty of Engineering of the Universidad Autónoma de Campeche, (Campus V) Second Stage

*Universidad Autónoma de Campeche*

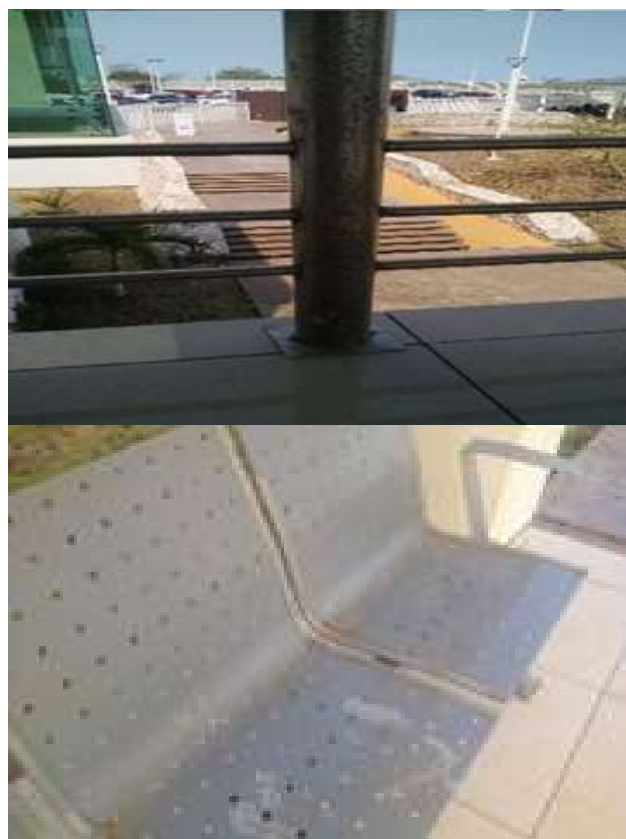
**Figure 15** Corrosion in metal structures

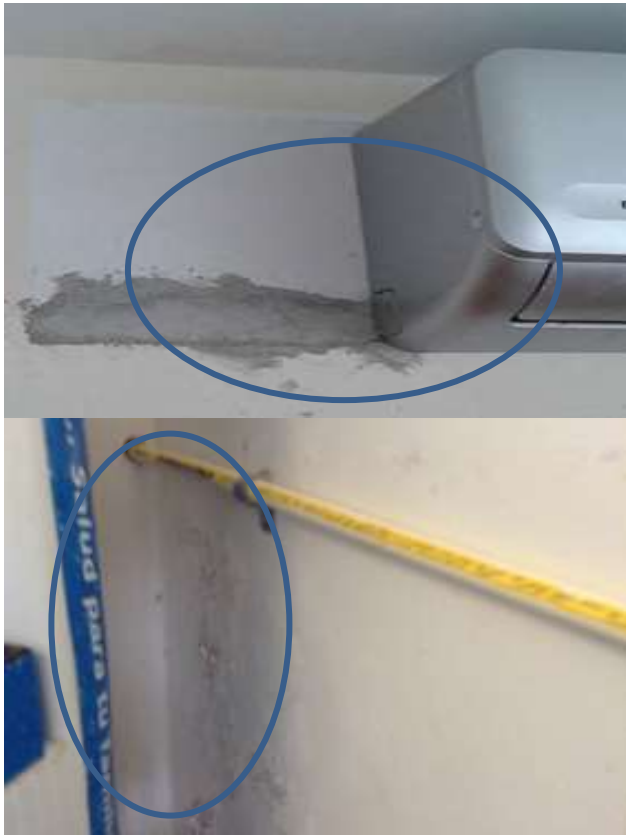
**Figure 16** General damages in painting  
*Source: Own*

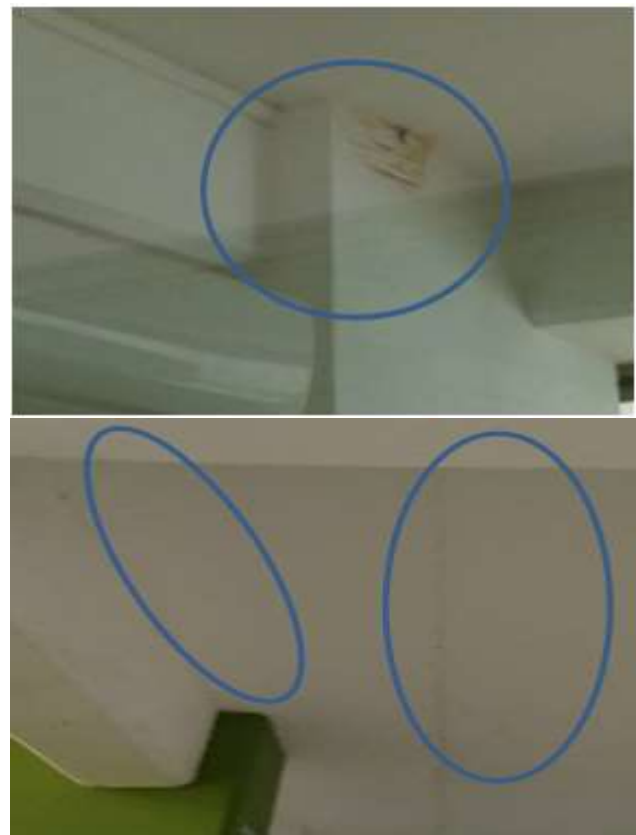
**Figure 17** Presence of cracks and dampness  
*Source: Own*
