Effects of the earthquake of September 19, 2017, in homes, in the municipality of Chietla, Puebla

Efectos del terremoto del 19 de septiembre de 2017, en viviendas, en el municipio de Chietla, Puebla

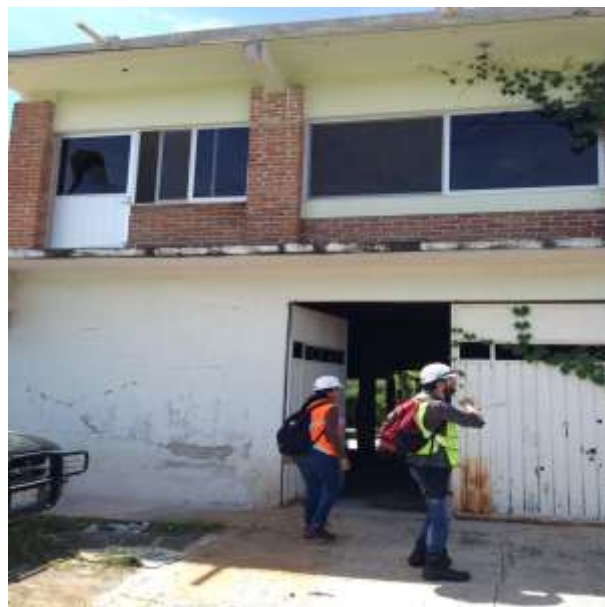
Figure 1 Buap students

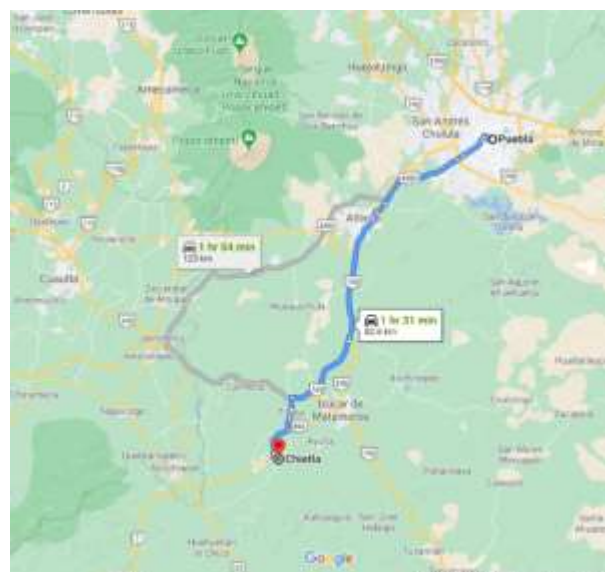
Figure 2 Location of Chietla
Source: Google maps, 2020

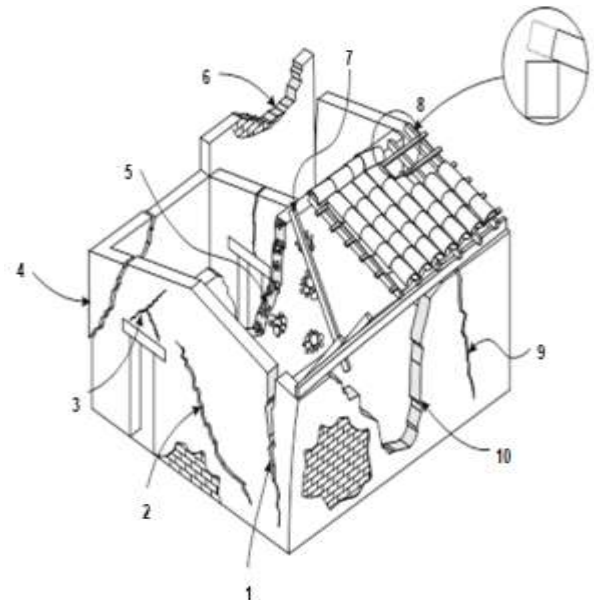
Figure 3 Common damage to adobe homes. 1. Vertical crack in corners by flipping walls. 2. Sloping cracks in walls. 3. Sloping cracks in enclosures. 4. Dislocation of corners. 5. Collapse of stone and mud walls. 6. Fallen parapet. 7. Fallen roof. 8. Beams run about to fall. 9. Vertical cracks in walls. 10. central turning on long walls
Source: (CENAPRED, 2018)

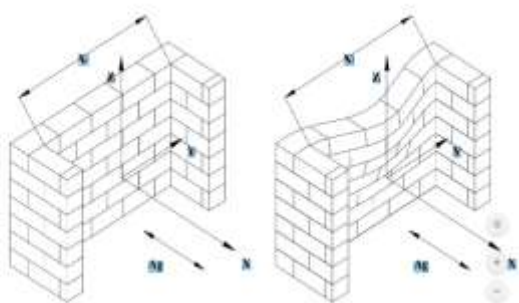
Figure 4 Orientation of the wall with respect to the acceleration at the base and deformation of it. It shows the orientation of the wall under study with respect to the requesting acceleration and the reference axes, X, Y and Z that indicate: the direction perpendicular to the plane of the wall, the horizontal direction along the wall and the vertical direction, respectively. X Y Z L Ag X L Z Y
Source: Jaramillo, 2002

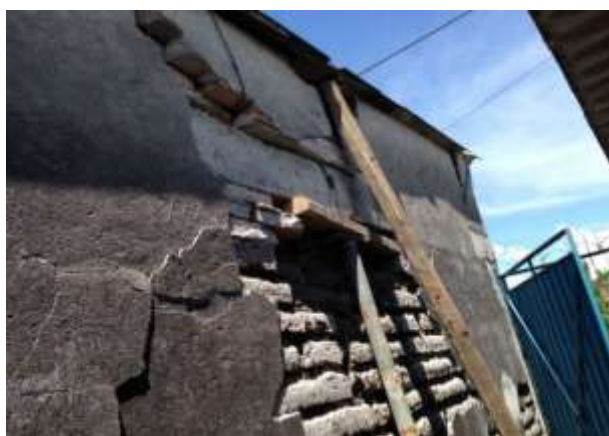
Figure 6 housing where the bending perpendicular to the plane of the adobe wall intensified by the structural failure of the enclosure is shown because the confined wall is not found and there is no effective distribution of the loads
Source: Faculty of Architecture BUAP, 2017

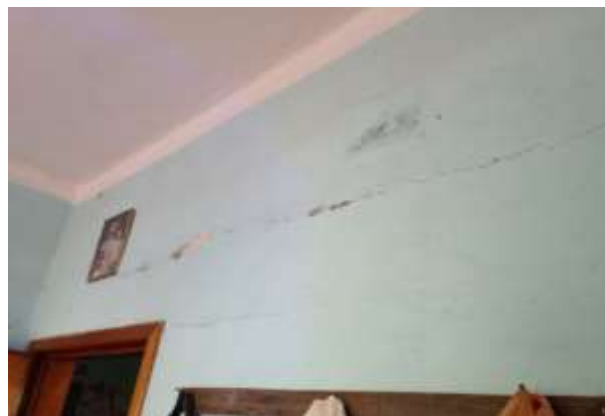
Figure 7 The longitudinal fault is seen in the image at the top
Source: Faculty of Architecture BUAP, 2017

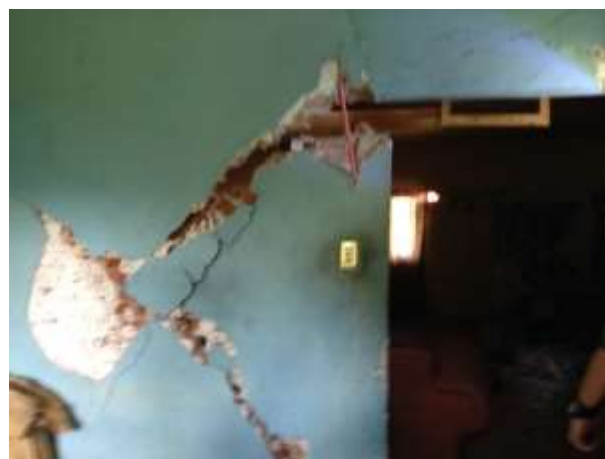
Figure 9 It fails by bending perpendicular to the plane of the wall by crushing the segments of the wall generating compression forces that increased until they reached the axial compression resistance of the masonry
Source: Faculty of Architecture BUAP, 2017

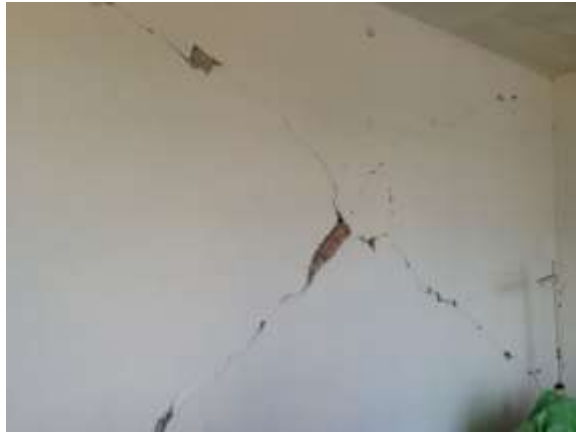
Figure 10 It fails by bending perpendicular to the plane of the wall by static instability of the segments caused by the rigidity of the upper dala
Source: Faculty of Architecture BUAP, 2017

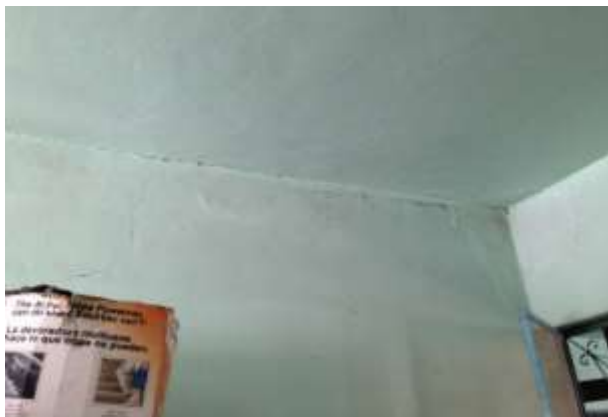
Figure 11 Unconfined walls, observed at the top of the wall, the separation of the wall with the roof
Source: Faculty of Architecture BUAP, 2017

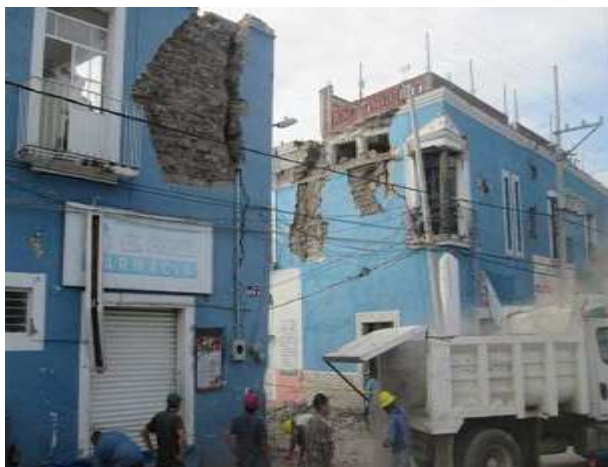
Figure 12 Unconfined walls, observed at the top of the wall, the separation of the wall with the roof
Source: Cano, 2020

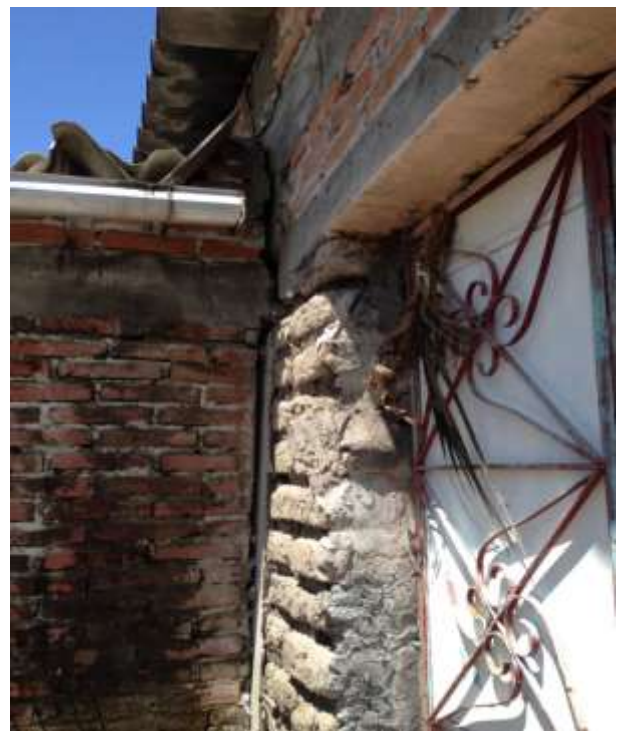
Figure 13 One of the problems encountered is that adobe dwellings are integrated with reinforced concrete frames and covered with reinforced concrete or ribbed asbestos
Source: Faculty of Architecture BUAP, 2017

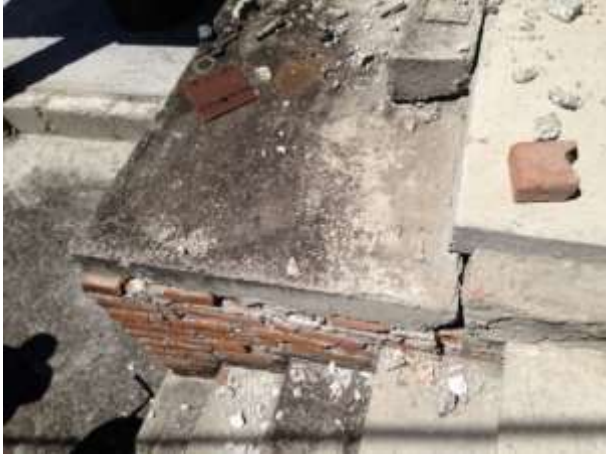
Figure 15 In several houses it was observed that the constructions of unconfined masonry were placed reinforced concrete roofs that caused separation between the slabs and compression in the walls

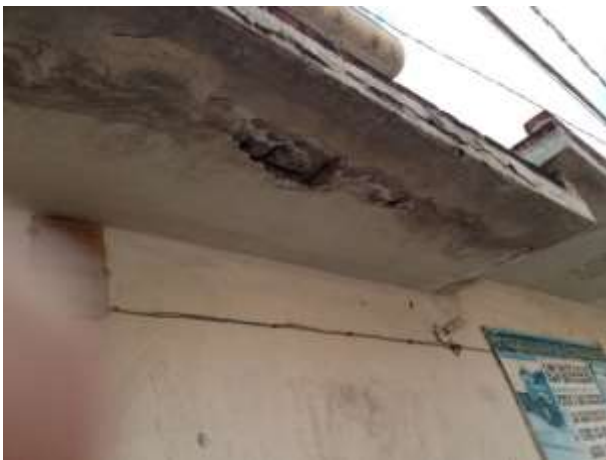
Figure 16 A common problem was that the eaves were too long and flexed causing cracks that moisture caused the degradation of the materials

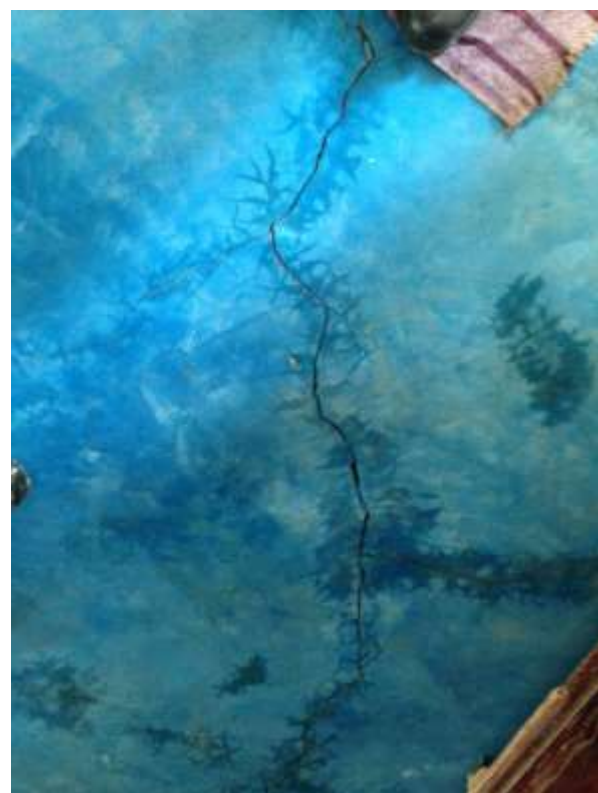
Figure 17 It was observed that there were already cracks produced by other earthquakes, in which the humidity caused more fissures than in the earthquake of 2017 were evidenced
