## Architectural proposal for the rehabilitation and improvement of the houses of the city Yagúl housing unit, Oaxaca

HERNÁNDEZ-RODRÍGUEZ, Miguel Adrián†\*, GÓMEZ-BARRANCO, Heidy and RODRÍGUEZ-SÁNCHEZ, Luz Cecilia

*Universidad Autónoma Benito Juárez de Oaxaca (UABJO), Faculty of Architecture "5 de Mayo", Academic Body "Technology and Sustainability". 5 de Mayo No. 111, Historic Center, Oaxaca, Oax. Mexico. 68000.*

DOI: 10.35429/JAD.2021.14.5.27.36

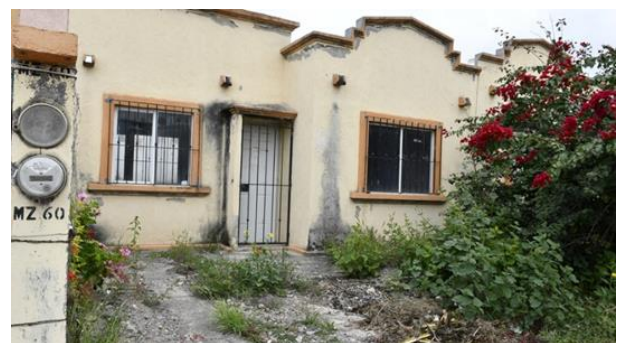
During the visual inspection, several signs of deterioration in the structure could be observed, as shown in figure 1, which include cracks, humidity, signs of exposure and corrosion of the reinforced steel and the presence of leaching salts in the bed. bottom of the slabs, also subsidence of the ground in some houses.

**Figure 1** Cracking and moisture in the walls and slabs

As can be seen in the non-destructive tests carried out on the houses, they are structurally weak, so a structural improvement based on confinement with castles and girders is proposed, which will give us structural security and support for the next improvement mentioned below.

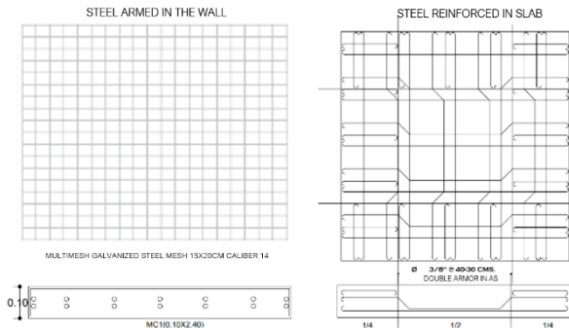
Galvanized Steel Multimalla Mesh 15x20 cm Cal 14 was used for the construction of the houses, with an average covering of 14mm, the reinforcement details are shown in figure 2.

**Figure 2** Detail of steel reinforcements

The analysis of the quantity of steel, allowed to determine the variable or null presence of steel in the structure, using Galvanized Steel Multimalla 5x10 cm Cal 14.

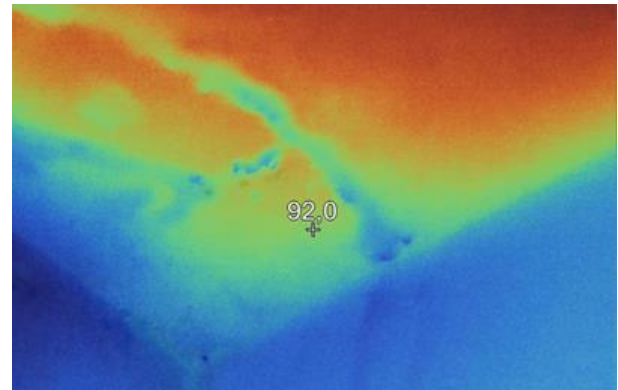
The ceiling temperatures indicated by the camera when the emissivity is close to its real value, oscillate between 36 and 39oC, (figure 3) unreasonable values for interior surface temperatures, it should be noted that, for qualitative applications, the use of a u Another emissivity does not affect more than a change of scales to adjust the colors of the image, finding a lot of humidity in these adjoining all the walls.

**Figure 3** House bedroom thermography 2

A great accumulation of heat was found, mainly in the slabs, due to the fact that they are made of concrete and are located at a very low height, in addition, a large amount of humidity is appreciated in the upper and lower part of the walls.

Moisture in reinforced concrete, usually occurs by capillarity, when the water rises from the ground through the material; or filtration, when water (usually rainwater) enters the interior of the building either by absorption, infiltration or penetration.

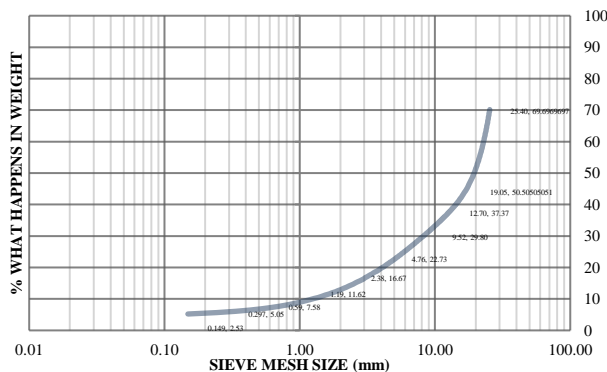
Table 4 Results of granulometric tests

GRAPHIC GRANULOMETRIC SAMPLE A-1.00 mts

The results showed that the type of soil is defined as follows: Poorly graded sands, a mixture of silts and clays of low compressibility, which indicates that the soil has a  $q_r = 7.5 \text{ kg/cm}^2$ .

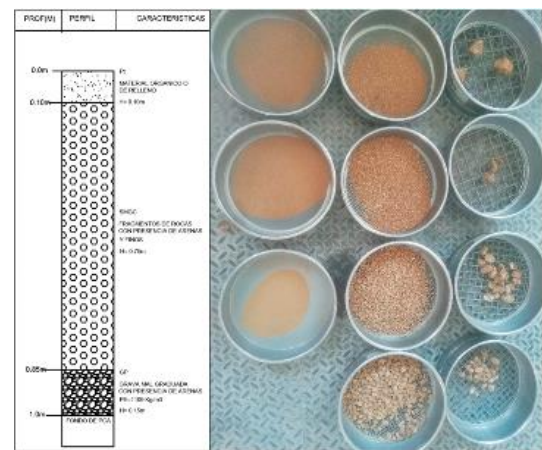
Having said this, we can determine that the type of foundation used is not adequate and because of this the house can be affected by sand displacement or subsidence since clays of low compressibility are present.

Figure 4 Stratigraphic profile and granulometry of the soil
