## Failure in a pipe due to defective maintenance

This work consisted of a failure analysis performed on a 20-inch diameter "T" type connection, which plays an important role in the energy transport process. The objective of this work was to determine the metallurgical mechanism, which led to the fracture of this component and with this work it is shown that a poor practice in preventive maintenance leads to process failures and unplanned stoppages.

The construction of this "T" type connection dated from 1980 and the material was ASTM A 53 grade B steel. This component was approximately 2.30 meters long, 500 millimeters in diameter and approximately 7.85 millimeters thickness.

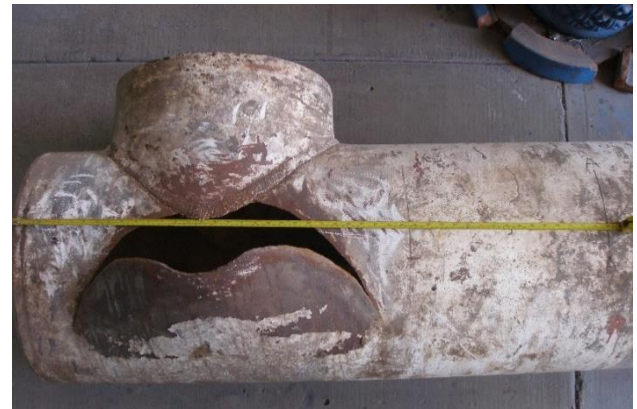
It should be mentioned that the thickness was not constant since the specimen under study showed red oxidation on both sides; the "T" connection was 500 millimeters in diameter, in addition to a 300 millimeters of diameter hole. There was a primary crack that began transversely to the radius of the tube and then towards a semicircle of approximately 50 centimeters long whose possible origin was detected in the joint weld of the "T" with the tube. This is shown in figure 1.

**Figure 1** The image the connection type "T" in the condition of delivery to the laboratory. Note the fracture and coating on the external surface

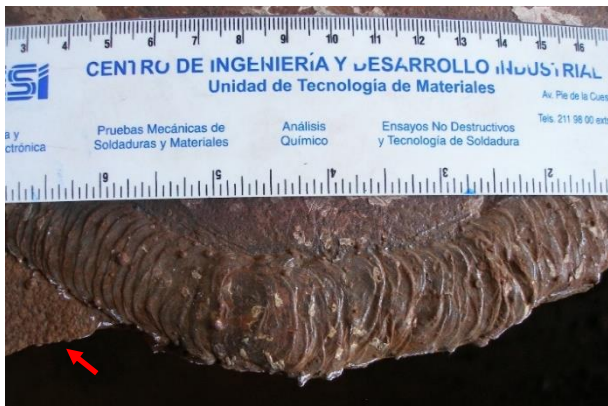
Visual testing on the "T" type connection showed that the pattern of the crack at the ends was ductile and that the origin was located in the weld toe of the "T" connection (figure 2). From this fact it can be deduced that the origin of the crack was located at the weld toe and that the fracture was initiated by some defect in it.

**Figure 2** The image shows the fracture zone in the region of the weld

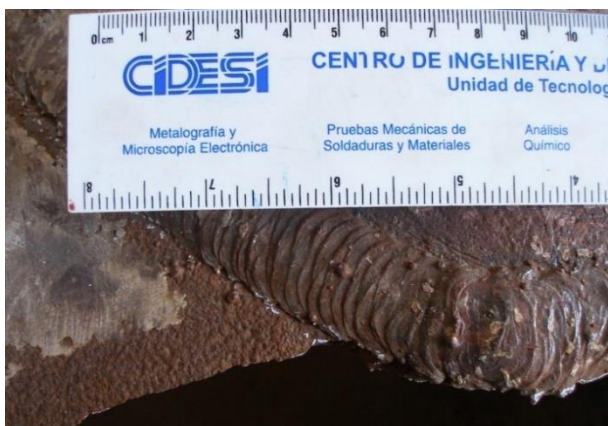
Moreover, it should be mentioned that by this technique, corrosion pitting was found in the area near the crack (figure 3). Figure 3 shows that the crack grew following the regions of the material with reduction in thickness due to corrosion, since the crack changed its path respecting to the origin located at the weld toe.

**Figure 3** The image shows the right area of the crack. There is seen the change in crack growth from the weld toe to the body of the pipe

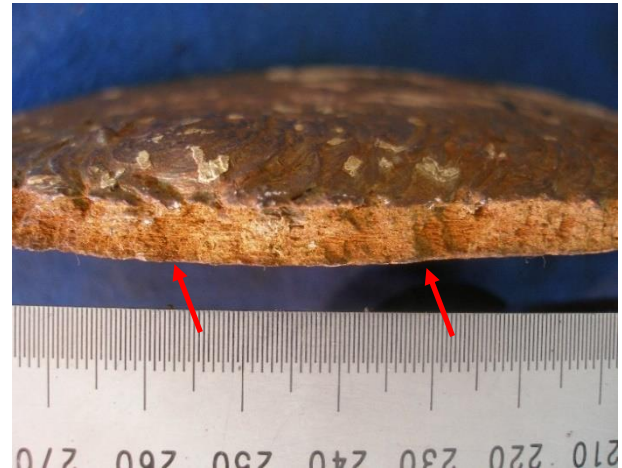
Visual testing of the fracture surface showed an incomplete fusion and a layer of red corrosion products. This evidence is shown in Figures 4. With this evidence it is verified that the welding defects played a role in the crack growth of this component.

**Figure 4** The image shows the fracture surface. The fracture surface is covered with a layer of red corrosion products and there is seen a lack of fusion

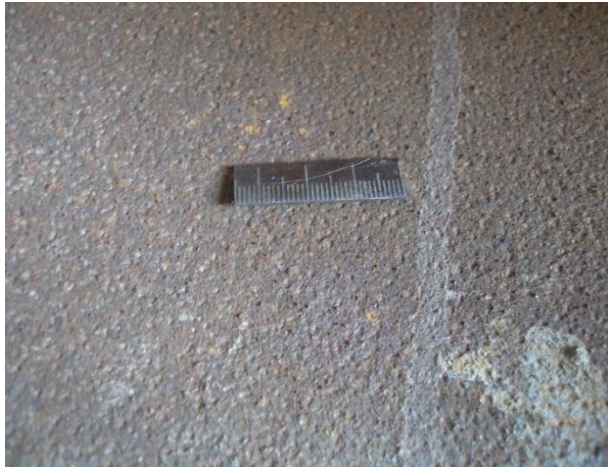
In the same way, visual testing also revealed the existence of red corrosion products inside the "T" connection, which indicates that there was oxygen corrosion in this part of the component. This resulted in a loss of thickness. Figure 5 shows evidence of corrosion pitting inside the "T" connection.

**Figure 5** The image shows corrosion pitting inside the tube. (The layer of red corrosion products was removed from the surface)  
Source: Own work

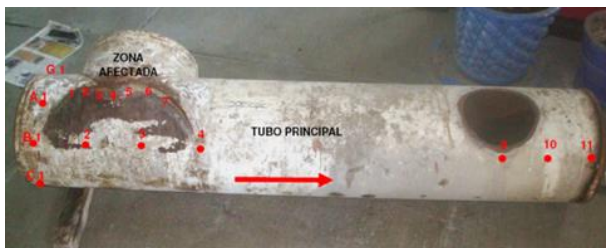
**Figure 6** The image shows the regions where the thicknesses measurements were carried out  
Source: Own work

From Tables 1 and 2 it can be noted that the maximum thickness of the main tube was 5.92 millimeters; while the minimum thickness detected was 5.31 millimeters and this was in the pitted area (close to the fracture surface). Perhaps this data does not seem relevant but if this reduction in thickness in this area of “T” the component is combined with the welding defects found by visual inspection, we can deduce that the stress applied by the internal pressure of the tube in this region of the connection was more higher than in other regions of the same specimen.

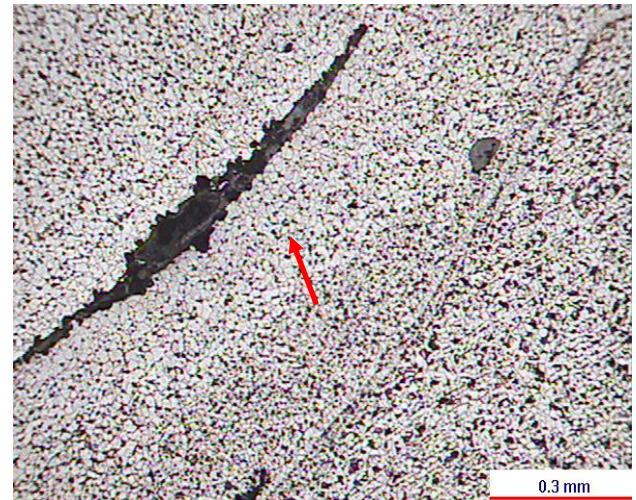
The metallographic analysis carried out in different regions of the “T” connection showed evidence that defects such as: trapped slag or lack of fusion, which serve as stress risers. This is shown in figure 7.

**Figure 7** Microstructure of the welded joint. Incomplete fusion is observed  
Source: Own work

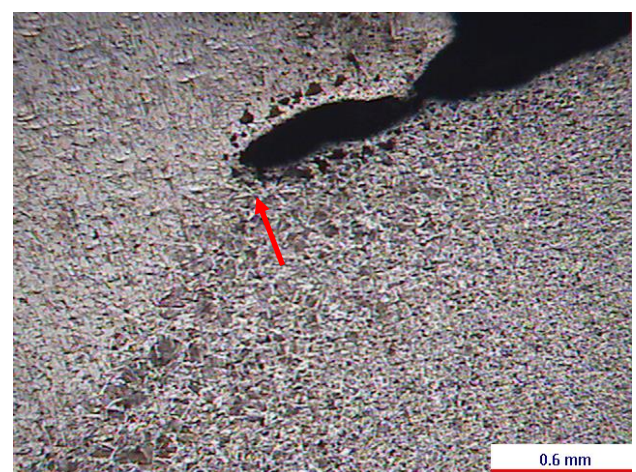
Similarly, the cross-sectional micrograph at the weld joint showed evidence of a fold on the outside of the weld. This can be seen in Figure 8. Besides, metallographic analysis confirmed the presence of corrosion pitting within the tube material of the “T” connection in the fracture region of the specimen. This fact is very important since corrosion pitting is a very severe form of damage; because the bites act as stress concentrators. This can be seen in figure 9.

**Figure 8** Microstructure in the fold of weld  
Source: Own work

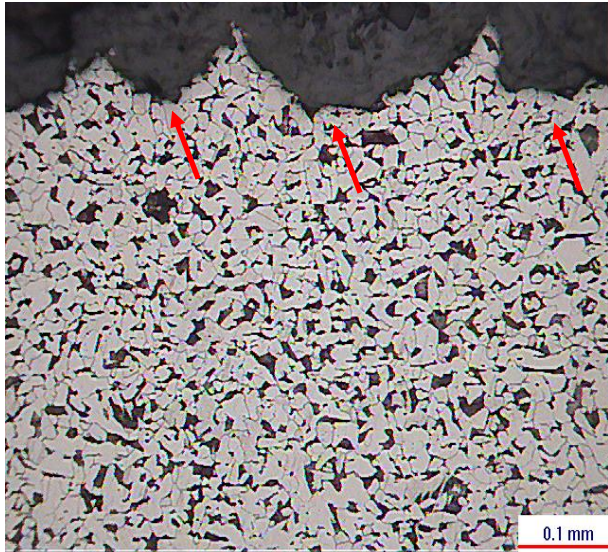
**Figure 9** Micrograph at 200x. There is seen the microstructure of the base material and pitting on the outer surface of the base material

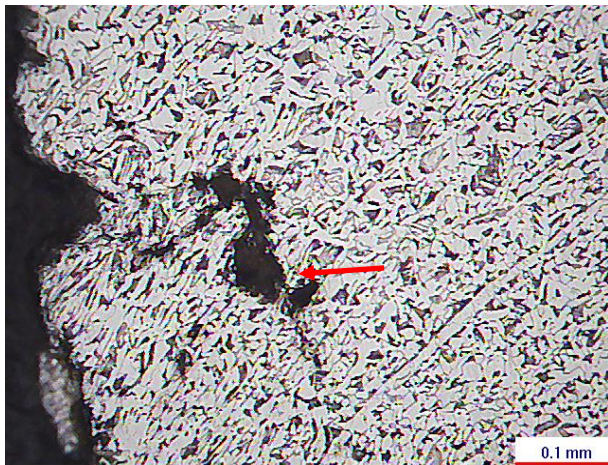
Figure 10 shows the microstructure in a cross section to the fracture surface of the “T” connection, there is evidence of corrosion pitting and a secondary crack that grows from the pit.

**Figure 10** Micrograph at 200x. Microstructure near the crack

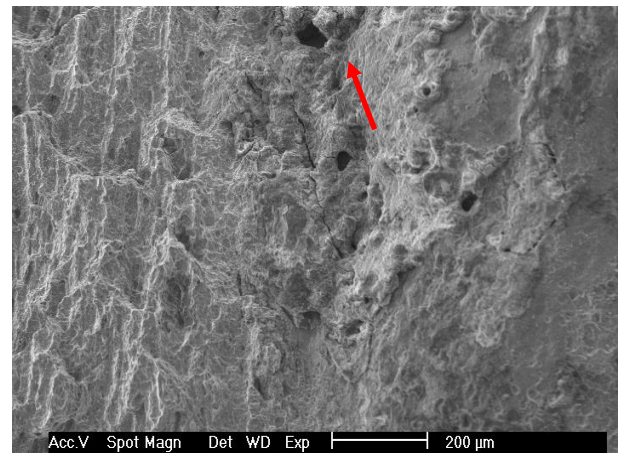
The fractographic analysis showed beach marks near the origin of the crack. This means that the crack growth occurred due to fatigue (figure 11). However, it should be mentioned that the corrosion degraded the evidence. Furthermore, weld defects such as incomplete fusion and porosity were found in this region of the fracture. This fact shows that these defects are stress risers where fatigue cracks began. This matches with the fact that this component works in compression cycles during oil / decompression transport.

**Figure 11** Fracture surface in the partial fusion zone. Incomplete fusion, porosity cavities and secondary cracks are observed

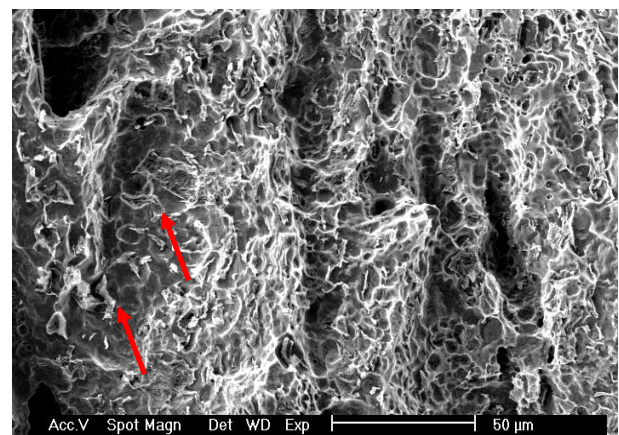
On the other hand, in the area of the crack where it grew away from the weld toe, a wooden pattern was observed (figure 12). This pattern is the mixture between a cleavage and dimples.

This fact indicates that the crack grew from welding defects due to the fatigue mechanism and then it finished cracking due to an overload.

This overload was conjunction of the work stress of the connection acting in the region of the pipe with thickness reduction. This region that had to withstand the work effort was reduced in mechanical strength due to the reduction in thickness caused by corrosion pitting.

**Figure 12** Fracture surface at the crack tip away from the welded joint. The image shows cleavage and dimples
