Detection of internal corrosion by long-pulse thermography and digital image processing

Citation: CASTILLO-VALDEZ, Georgina, LARIA-MENCHACA, Julio, GÓMEZ-CARPISO, Santiago and SANDOVAL-SÁNCHEZ, Juan Antonio. Detection of internal corrosion by long-pulse thermography and digital image processing. ECORFAN Journal-Democratic Republic of Congo. 2023, 9-16: 22-31

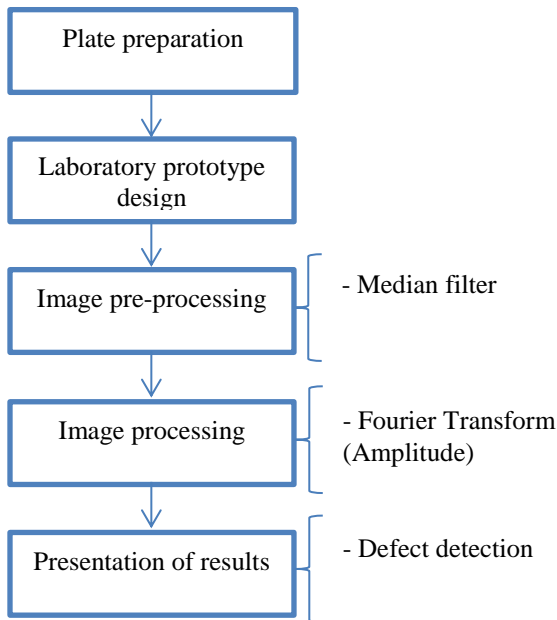
Figure 1 Solution approach for corrosion detection

The proposed approach consists of five stages, which are shown in Figure 1 and described as follows.

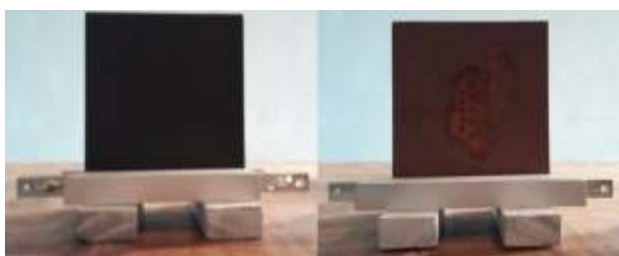
Figure 2 (a) Plate 1 outer side, (b) Plate 1 inner side

At this stage, A36 steel samples of size 15 centimetres wide by 15 centimetres long were prepared. Subsequently, holes of different diameters and depths were drilled in the central part of all the plates on the internal side, without going through the plate. Afterwards, salt water was added to the holes to cause corrosion, as well as residues of a corrosion rod, this process took about 3 weeks. As a next step, the plates were painted black on the outer side to improve the efficiency of the power source and reduce light reflection (Duan *et al.*, 2019).

The first plate, which will be referred to as plate 1, has a thickness of 2 millimetres and is shown in Figure 2.

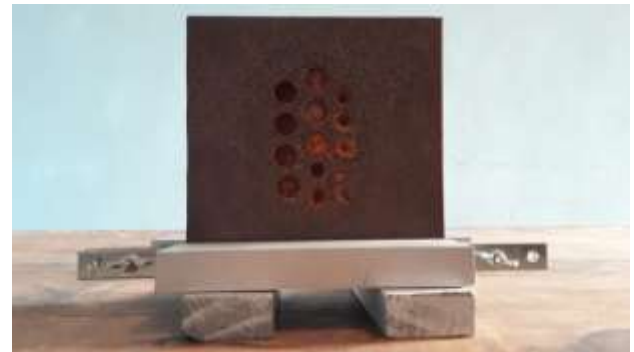
Figure 3 Plate 2 inner side

Plates 2 and 3 have a thickness of 8 mm, as shown in Figures 3 and 4 respectively.

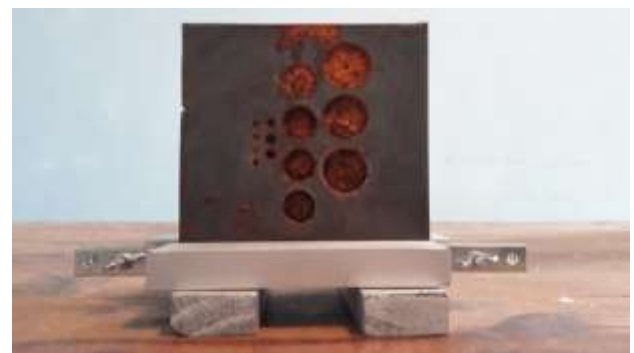
Figure 4 Plate 3 inner side

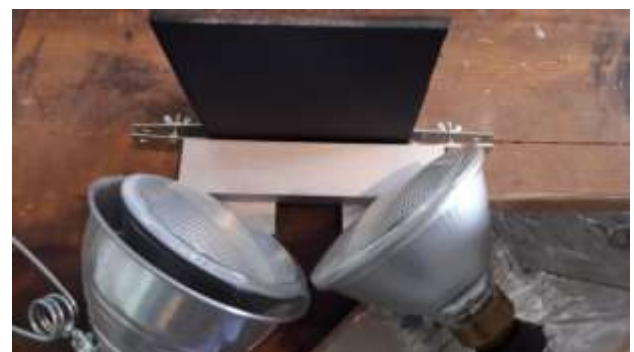
Figure 5 100 Watt halogen lamps.

For the implementation of the prototype, two halogen lamps of 100 Watts each (Figure 5), a thermographic camera (Figure 6), the steel plates presented in the previous section and a computer were required. The thermographic camera was provided by the Polytechnic University of Altamira on loan.

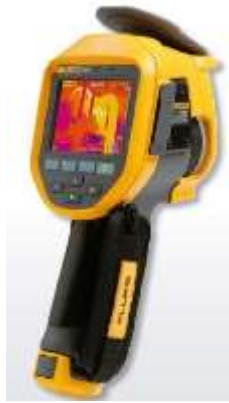
Figure 6 Thermographic camera
