Characterization of adobe bricks used in developing countries: Mexico as a case of study

GUTIÉRREZ-VILLALOBOS, José Marcelino†*, MORENO-MARTÍNEZ, Jatziri Yunuén, CATALÁN-QUIROZ, Policarpo and GALVÁN-CHÁVEZ, Arturo

DOI: 10.35429/JAD.2021.13.5.1.12

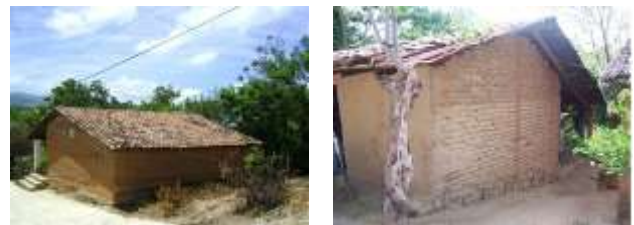
Adobe houses built in Mexico are one-story dwellings (Figure 1). The rectangular floor plans have average areas of 30 to 50 m², the longitudinal walls are 2.4 to 2.7 m high and the transverse walls are 3.0 to 3.9 m high. Wall thickness is typically 28 to 35 cm. Adobe houses do not usually have intermediate dividing walls (Figure 1). They have one or two access doors, located on the longitudinal walls, 0.7 to 1.2 m wide and approximately 2 m high. Typically, there is a 0.3 to 1 m² window on a longitudinal wall. Wooden lintels, 3 to 5 cm thick with supports approximately 20 to 30 cm long, are placed on the doors and the windows.

Figure 1 Typical adobe houses in Mexico
Self-Authorship

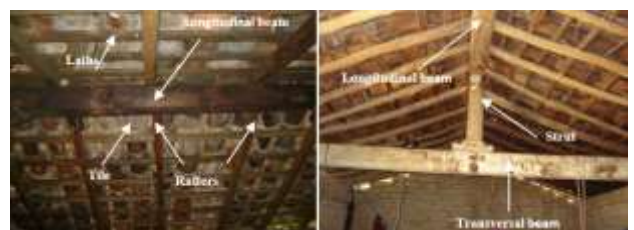
Figure 2 Roof system in adobe houses
Self-authorship

The roof system (Figure 2) is either flat or pitched at an inclination anywhere from 15 to 30 degrees. The roof cover is fabricated from annealed clay tile mounted on a robust longitudinal wooden beam that rests on the transverse walls (head walls) and on two wooden struts; the latter are connected to a transverse beam, equally spaced, and resting on the longitudinal walls.

Wooden rafters, also known as "madrinas" or battens, are placed approximately 60 cm apart on the walls and longitudinal beam rest. Transversing the rafters, wooden laths are placed every 25 cm to support the annealed clay tiles (Figure 2).

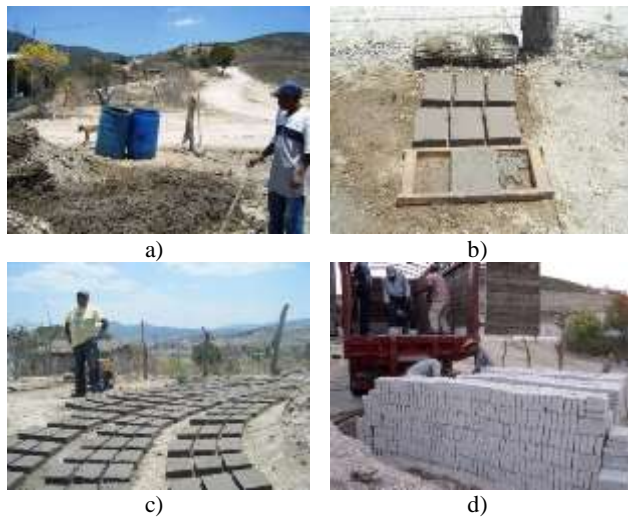
For the fabrication of adobe bricks, the mixture of the materials is done by hand, it is the materials (Figure 3a) and auxiliaries with a hoe, as a result a more uniform and malleable mixture is obtained. To this was added more water for use in wooden molds (Figure 3b).

Figure 3 Fabrication and transportation of adobe bricks: a) mixture of materials; b) wooden molds; c) adobe bricks are dried under the sun; d) Transportation of adobe bricks. Self-authorship

The mold is well filled, it is compacted with the fists until it is sure that there are no air spaces. It is recommended to pair with a metal or wood ruler the wooden molds for the adobes, following the traditional procedure for the elaboration of the pieces. We let it stay in water for a day so that it absorbs enough water. Later, they were placed on the ground, this has to be flat, dry and outdoors in a place (Figure 3c) where they received direct sunlight and plenty of air to dry completely during 1 to two months approximately. Then the pieces are transported to use them (Figure 3d).

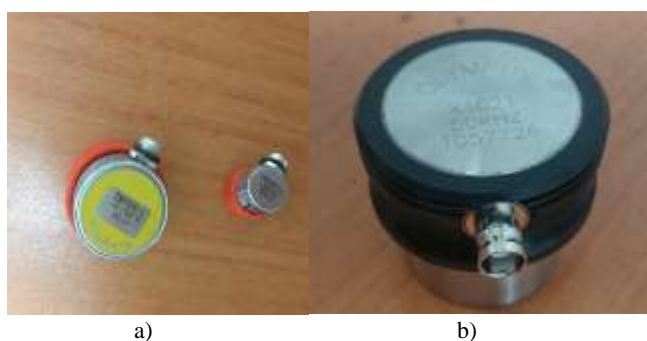
For this study about adobe masonry non-destructive tests, the method used for this research is based on the ultrasonic reflection method. This method consists of an ultrasound generating source and two piezoelectric transducers (Figure 6), one set as a transmitter and the other as a receiver. In this process, ultrasonic waves are generated by a transducer with operating frequencies above 20 kHz, this means wavelengths between 50–100 mm in adobe masonry as in Fortineau *et al.* (2017). In this research work, a transducer of 50 kHz, such as the one shown in Figure 6b, is used.

Figure 6 Piezoelectric transducers: a) transducers of 5000 kHz; b) transducer of 50 kHz
Self-authorship

Ultrasound pulse measurement were conducted using equations from (1) to (4), the setup for tests is presented in Figure 6. In this figure, a test performed on one of the pieces is shown. The 45° collation and coupling agent between the wedges and the piece. Another important thing is that sensor should be coupled with the same agent to the wedges otherwise signal can be attenuated.

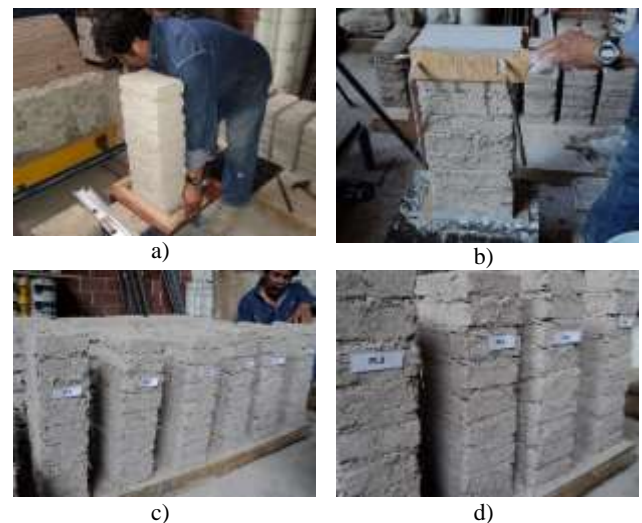
In first place, to obtain adobe masonry mechanical properties, nine pillars, considering adobe masonry built in the southeastern of Mexico, were constructed to carry out axial tests, as shown in Figure 7. In this form, the elastic mechanical properties of adobe masonry from the southeastern of Mexico were obtained. The volumetric weight of the material was 13.24 kN/m³.

Figure 7 Specimens built for compressive tests: a) construction of pillars; b) planar surface for performing a uniform stress distribution; c) storage of pillars; d) numbering of pillars
Self-authorship

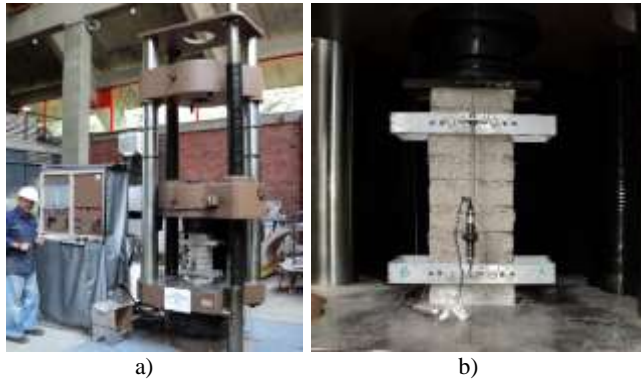
The specimens were tested in a Universal Machine whose maximum load was 2,200 kN, approximately. Instrumentation was performed using Displacement Transducers (LVDTs), as presented in Figure 8, and a Data Acquisition System (DAS). Thus, by placing the transducers on the specimen, it was possible to accurately know the displacement in that direction for each load step.

Figure 8 Adobe masonry pillar: a) Testing; b) Instrumentation
Self-authorship

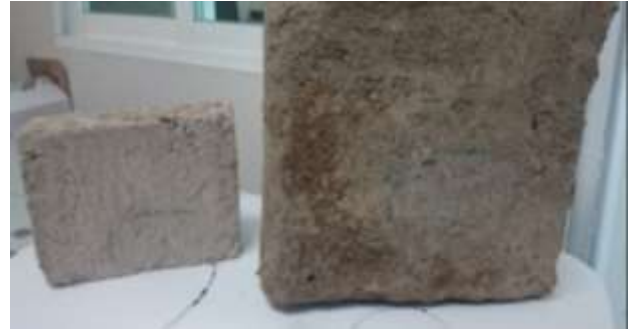
Even though, they were almost the same material and they were made following the same procedure, they presented some differences such as type of fiber and water level during mixing but in spite of that, their mechanical properties stayed alike. The two bricks are shown in Figure 7. Their physical properties are listed in Table 2.

Figure 10 Adobe bricks from the southeastern of Mexico (half scale) and from central part of the country (full scale)

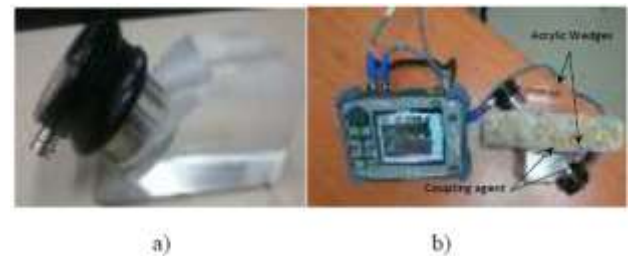
Besides the EPOCH 650, two 50 kHz ultrasonic transducers were needed to performance the measurements, these transducers are suitable to work with this kind of materials such as concrete, brick and inconsistent materials. Measurements were done on a fixed surface to avoid vibrations or natural disturbances and not to affect instrument readings. For transversal velocity measurement is necessary to use the 2 plastic wedges. Transducers and wedges are shown in Figure 11.

Figure 11 Measurement: a) 50 kHz transducer with plastic wedge; b) Setup for the brick from central part of Mexico
