**Adobe as a resilient material and the causes of its disappearance in construction****El adobe como material resiliente y las causas de su desaparición en la construcción**

VÁZQUEZ-TORRES, María del Rayo, CASTILLO-REYES, Alberto Rosendo, NAVA-RAMÍREZ, Rosario and MONTERO-URRUSQUIETA, Rubén Ángel

**Citation:** VÁZQUEZ-TORRES, María del Rayo, CASTILLO-REYES, Alberto Rosendo, NAVA-RAMÍREZ, Rosario and MONTERO-URRUSQUIETA, Rubén Ángel. Adobe as a resilient material and the causes of its disappearance in construction. Journal of Architecture and Design. 2021, 5-13: 38-50

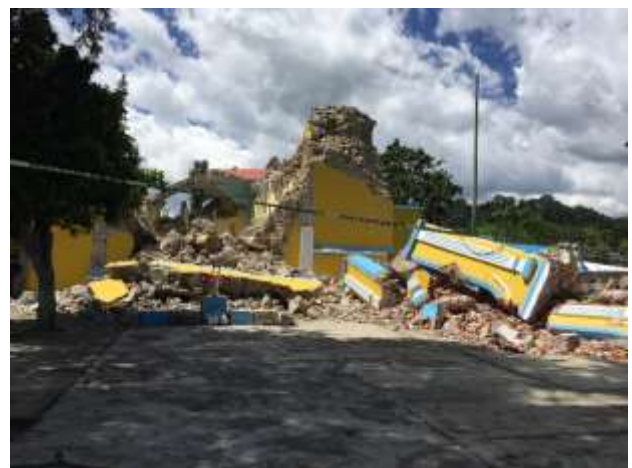
**Figure 1** Temple of San Juan Bautista, painted for the celebration of August 15 affected by the earthquake of September 19, 2017

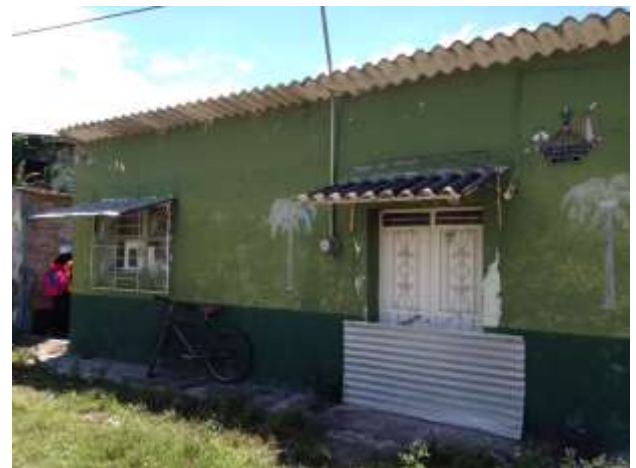
**Figure 3** Adobe house in Chietla, the epicenter of the 2017 earthquake that was not affected, due to its construction quality. Buap, 2017

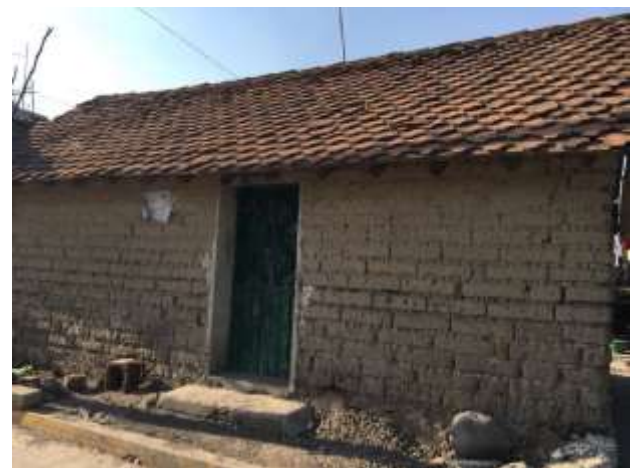
**Figure 3** Adobe house that was not affected, due to its construction quality. Huaquechula, Puebla, 2017

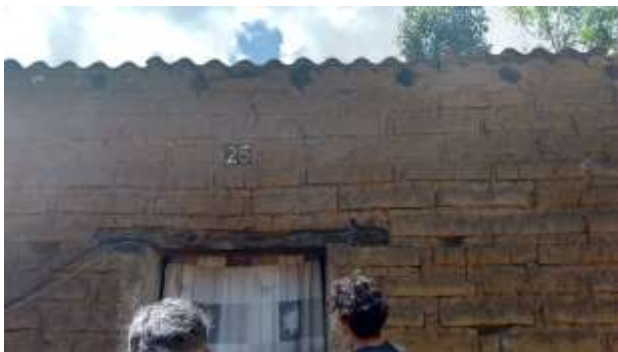
**Figure 6** Door lintel damaged by weathering that affects its useful life in San Juan Bautista, Tochimilco, Puebla, 2017

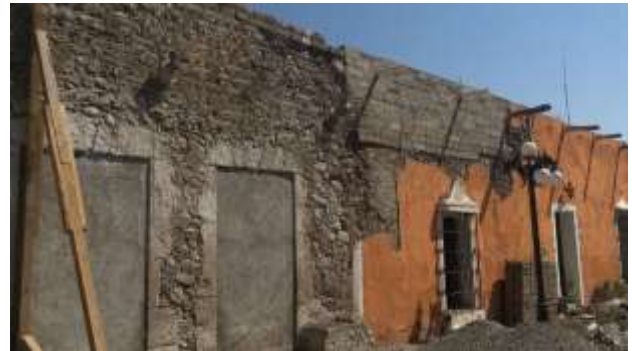
**Figure 7** After the 2017 earthquake, the parapets came off in buildings classified as historical heritage, which is why different materials were used in the intervention. In the case of the house on the right, it was made of a parapet with hollow cement blocks, which is a material incompatible with adobe. Atlixco, Puebla, 2017

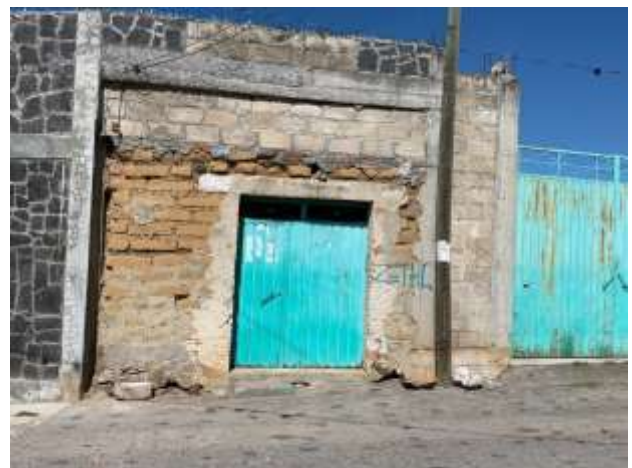
**Figure 8** Adobe house with interventions using, heavy block, stone and the inclusion of columns, chains and beams that modify its configuration. Huaquechula, Puebla, 2017

Walls were also weakened by enlarging windows and opening doors, or reinforced concrete elements were integrated by modifying their configuration.

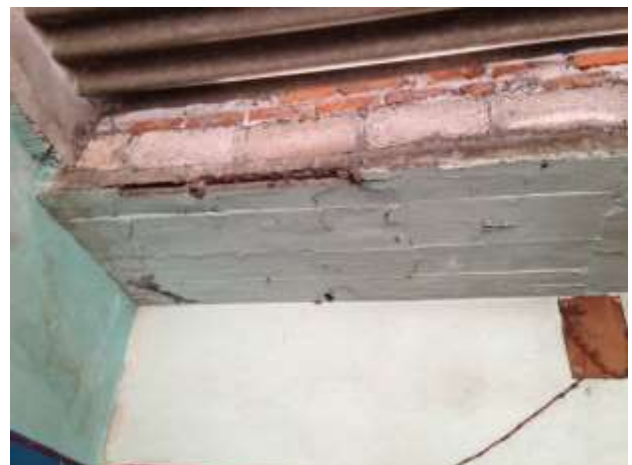
**Figure 9** Adobe house in Chietla, the epicenter of the 2017 earthquake, where reinforced concrete slab was incorporated. Buap, 2017

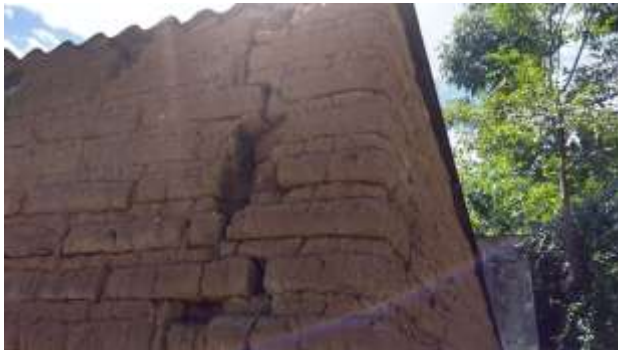
**Figure 10** Housing in the neighborhood of San Juan Bautista, affected by the earthquake of September 19, 2017. Tochimilco, Puebla, 2017

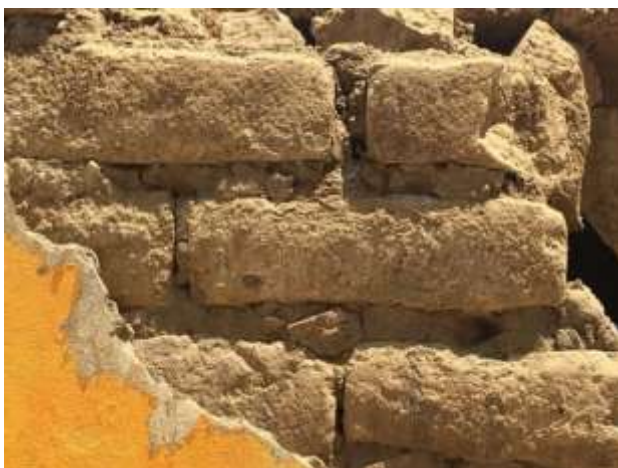
**Figure 11** Clay mortar that joins the adobe in a historic building. Tochimilco, Puebla, 2017

Originally the adobe was originally joined with clay mortars, however, later cement containing soluble salts was used, this was later eliminated from the cements, but caused the adobe to weaken or disintegrate or sandblast some blocks. Acid rain occurs when the humidity of the air combines with nitrogen oxides, sulfur dioxide or sulfur trioxide, also, the wind deposits these particles and when it rains they degrade the adobe. Sandblasting occurs inside and on top of it the material is apparently not damaged as a hardened crust is generated on the exposed part.
