Waterproofing materials used in buildings in the colonial period in Mexico: Case study Huichapan, Hidalgo

Tecnológico Nacional de México/Instituto Tecnológico Superior de Huichapan, Licenciatura en Arquitectura.El Saucillo, Huichapan Hgo, México. C.P. 42411.

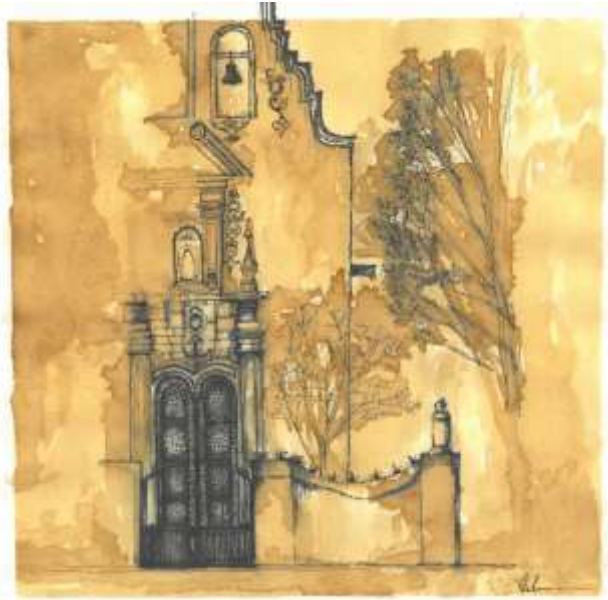
Figure 1 Composition of the main facade of a chapel as a representation of religious architecture in Huichapan, Hidalgo

In present-day Huichapan, it is common to find constructions from the 16th to the 20th century where the roofs show significant wear or even total collapse and loss of slab. It is worth noting that there is a category of Religious Architecture, where buildings belong due to their massive and monumental character. Figures 1 and 2 show, through artistic representation, the main facade and architectural plans of a chapel as a representation of religious architecture.

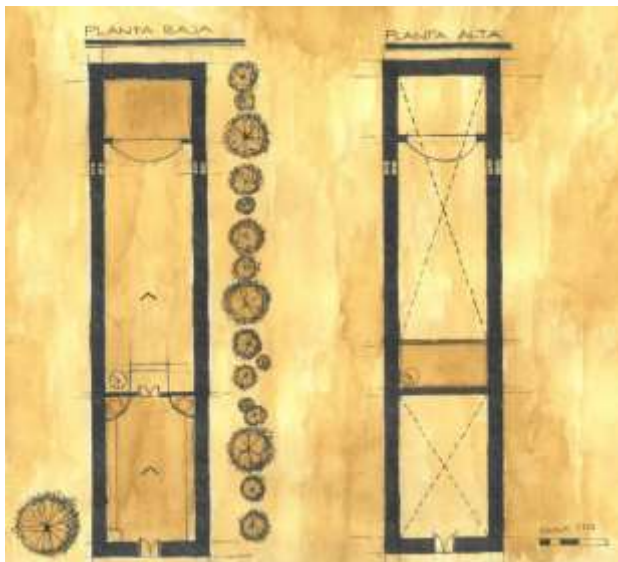
Figure 2 Architectural floor plans of a chapel as a representation of religious architecture in Huichapan, Hidalgo

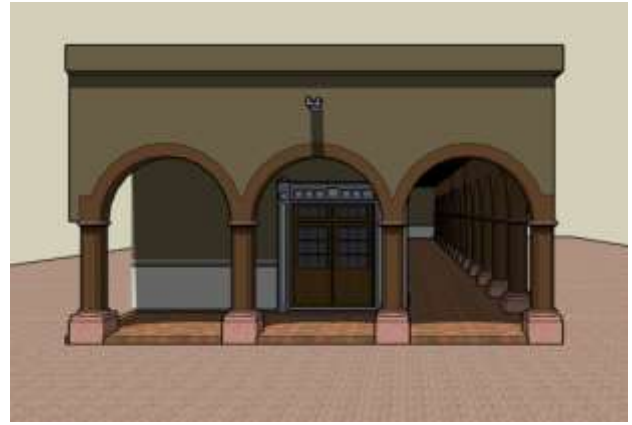
Figure 3 Graphic model of an arcade-type building as a representation of civil architecture in Huichapan, Hidalgo
Source: Own Authorship

There are two types; the first consists of constructions with architectural elements and religious precedents that play a significant role together. The second is on a smaller scale, involving residences that define and complement the urban landscape. As examples, in Figure 3, we identify a graphic model of an arcade-type building as a representation of civil architecture in Huichapan. Meanwhile, in Figure 4, we observe the architectural typology of a residence.

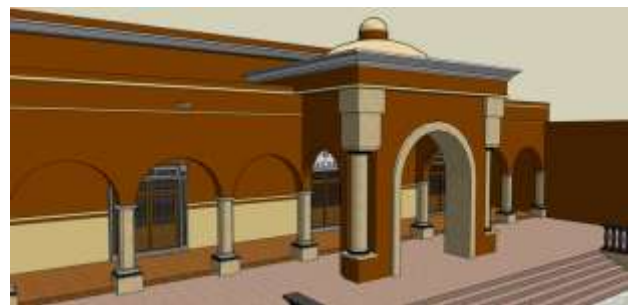
Figure 4 Graphic model of an arcade-type building as a representation of civil architecture in Huichapan, Hidalgo
Source: Own Authorship

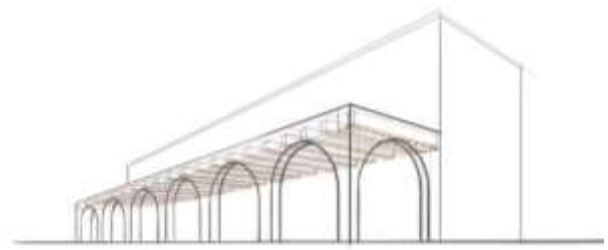
Figure 5 Composition of wooden beams in the archetypal arcade, represented in a two-point perspective on the section of wooden beams in colonial arcade porches, very common in New Spanish architecture
Source: Own Authorship

In Figures 5 and 6, we identify the wooden beams and their importance within the slab system, as well as their behavior in conjunction with the building as part of the construction and structural system.

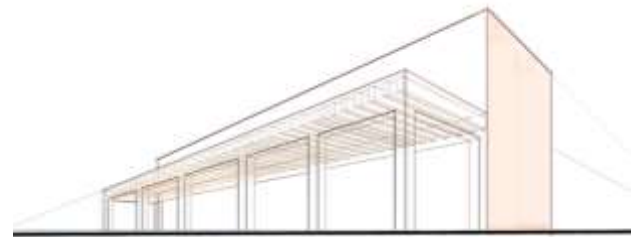
Figure 6 Composition of wooden beams in the archetypal colonnade, represented in a two-point perspective on the section of wooden beams in unadorned colonnade porches
Source: Own Authorship

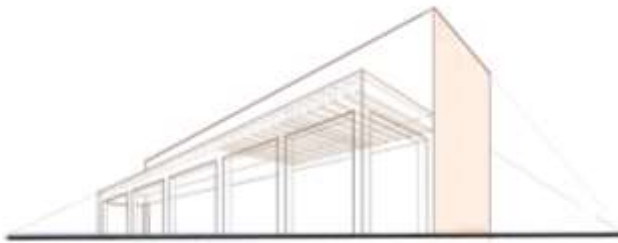
Figure 7 Composition of wooden beams in the archetypal colonnade. Two-point perspective representation on the section of wooden beams in colonnade porches, where the structure is marked up to the midpoint of the entire porch section, highlighting the critical point

As observed in Figure 7, when broken down, the structural relevance of a single clear span of the slab becomes apparent. It tends to be vulnerable to moisture from rain, exhibiting a tendency to flex in the slab and consequently sagging in the middle where the critical point is located.

It is important to analyze these diagrams to diagnose how materials behave, where there is a tendency to flex in the slab and consequently sag in the middle where the critical point is located.

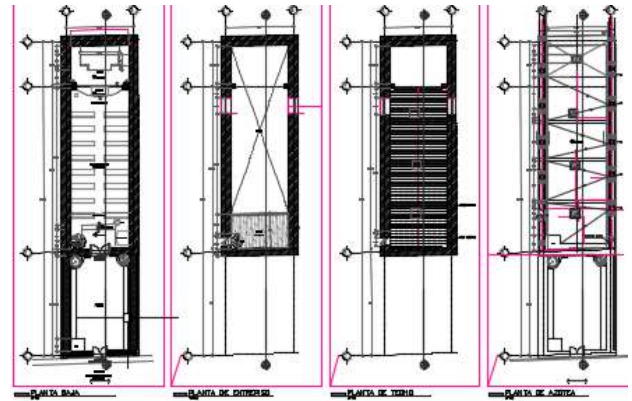
Figure 8 Architectural and typological plan of a religious building as part of the technical data sheet concentrating on construction systems and materials used in religious buildings

In Figures 8 and 9, we observe the architectural and tectonic plans, as well as a schematic section of a religious building, respectively, as part of the comprehensive technical data sheet for construction systems and materials incorporated into religious buildings.

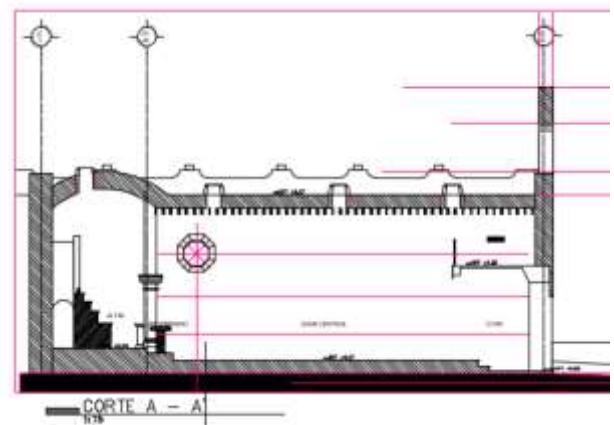
Figure 9 Typical schematic section of a religious building as part of the technical data sheet focusing on construction systems and materials used in religious buildings

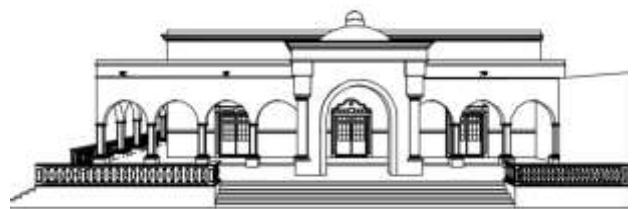
Figure 10 Schematic facade of a civil building as part of the technical data sheet concentrating on construction systems and materials used in religious buildings

In Figure 10, we observe respectively the typical architectural facade of a civil building as part of the technical data sheet focusing on construction systems and materials used in religious buildings.
