Preliminary study of thermography applied to diagnosed faults in Diesel Engine and network rack

CARDENAS-SANCHEZ, Enrique†*, DELGADILLO-PARTIDA, Jorge, RAMOS-PONCE, Manuel and RIOS-HERNANDEZ, Juan

Ingeniería en Mantenimiento Industrial, Universidad tecnológica de Manzanillo

DOI: 10.35429/JOCT.2023.19.7.29.36

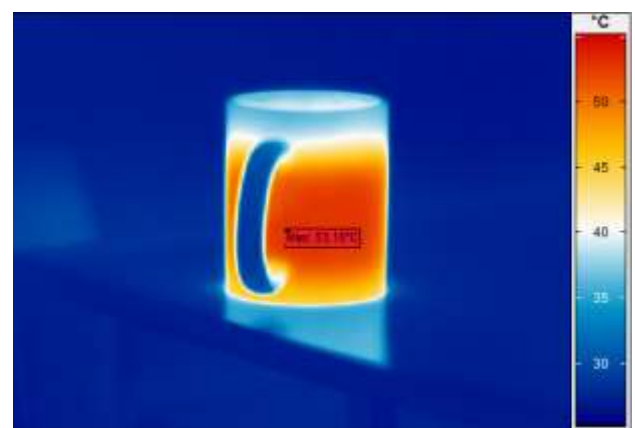
Figure 1 Example of emissivity measured on a coffee cup. Observe how it reflects the thermal radiation on the table on which it is placed. This radiation, if it were excessive, would explain why objects transmit part of the heat to their surroundings until thermal equilibrium is reached. Own image captured in the lab using Irbis 3 software

Figure 2 shows an example of a thermal image capture to observe the variation of cooling. We can also observe the emissivity of this reflected on the table. The rate is this is polished so the emissivity is very low (less than 0.3), according to table 2 (Cardenas-Sanchez, 2013). On the other hand, note that with this equipment and software we can monitor the maximum temperature (indicated in the coffee rate) and minimum (indicated by the software in the lower left corner) to give sequence to the phenomenon. In this case it is a test example.

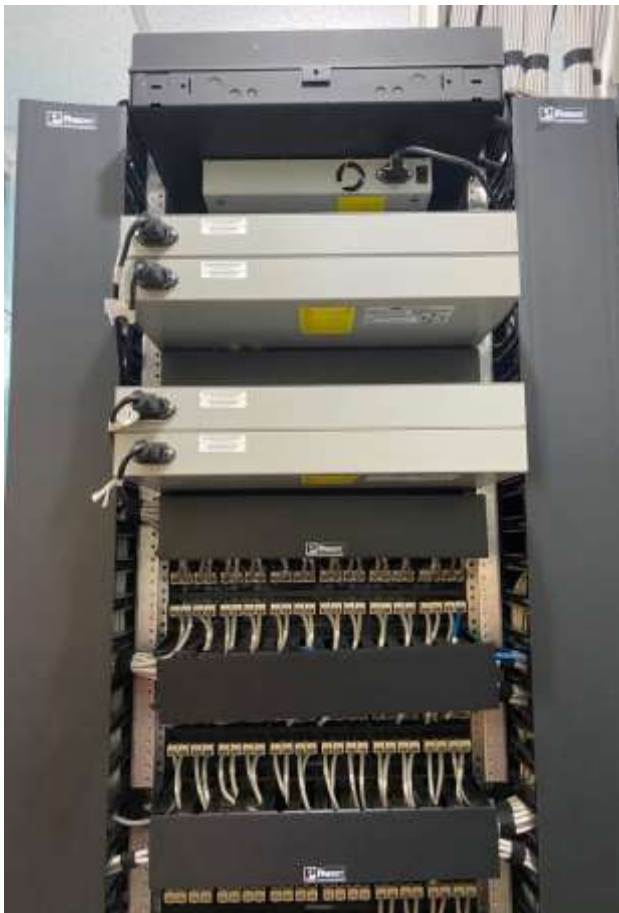
Figure 2 Front view of the Network Rack used for our experiment

In the case of the network rack, especially the 48-port Patch panel device, it is located at the Technological University of Manzanillo. The rack, Figure 3, the device, allows the connection of 48 nodes simultaneously, and it is in constant operation 24 hours a day in climate controlled conditions. The air conditioning indicates a temperature of approximately 24 degrees Celsius on average. However, for the measurement, we have captured data during 2 different stages of the day. The first stage was at 9 o'clock in the morning, as this is the peak time for users to connect. Finally, the second stage was set at 2 p.m., as this is the time when users are least likely to be online. For this experiment, sampling was carried out at a capture rate of 20 seconds per image for 30 minutes.

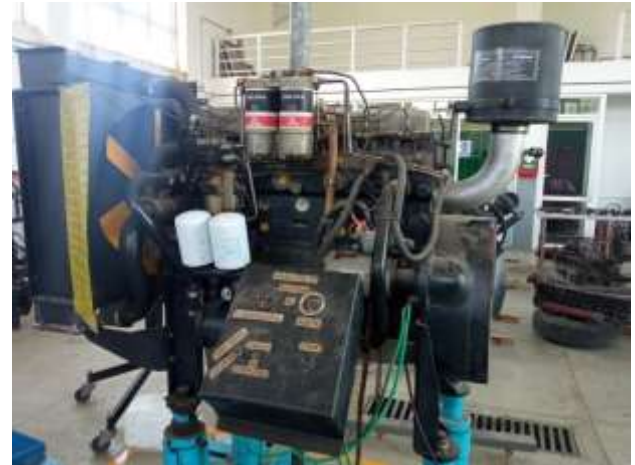
Figure 3 Diesel engine used for our experiment, Perkins model T 6.3544, 150 HP

Data capture shall be performed while the test engine is running. During a continuous period of 30 minutes, thermal data will be collected using a thermal camera at a rate of 20 images per minute. It should be noted that the engine has previously recognised and diagnosed faults, which allows the identification of specific problem areas. This process will be repeated to minimise possible measurement errors and ensure consistency of results, Figure 2.

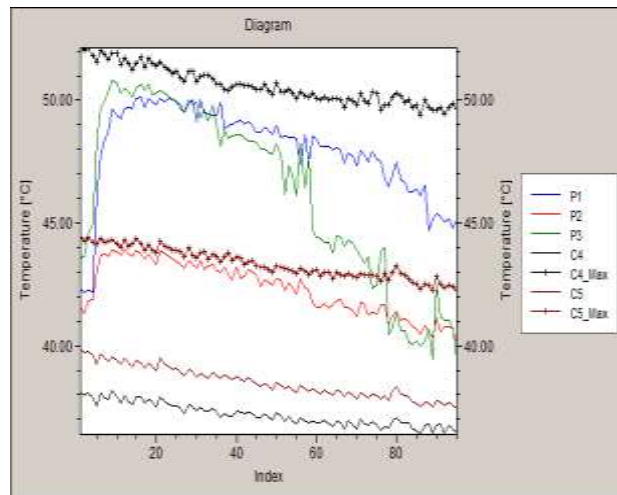
Figure 6 Anomaly analysis for the network rack using 90 images captured every 20 seconds. Note that some sampling points (P1, P2, and P3) decay with higher speed, these are sampling points (the size of the size of 1 pixel). On the other hand, the sampling areas (C4 and C5) show a curve with an almost constant mean value, because it considers the average value of the whole area.

According to our analysis, the 48-node patch has a higher heating than normal mainly during peak hours, that is during the early morning hours, when several users are connected simultaneously, figure 7. In the case of the cooling rate, the sampling areas (C4 and C5) have a lower decay compared to a specific point in the area (P1, P2 and P3), this may be due to the stability of the support used. It is therefore advisable to fix the thermal camera on a solid base, in case a similar analysis is desired.

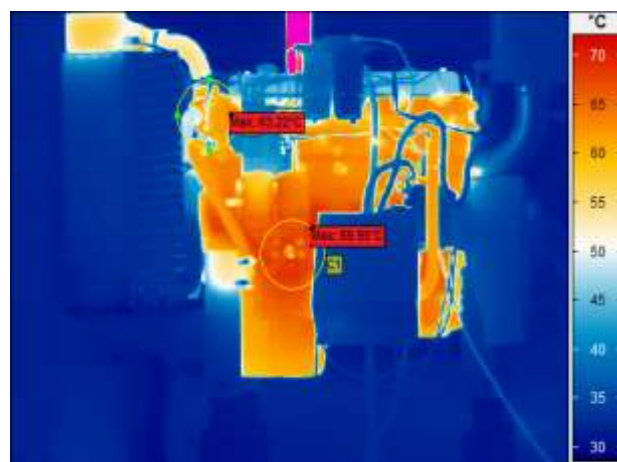
Figure 7 Test T-engine for our analysis with known faults. The image shows sampling areas with circle geometry listed as C1, and C2 respectively

In figure 8, on the combustion engine, it can be seen that there is no coolant circulation from the monoblock to the radiator and temperatures of 35 Celsius. On the other hand, for our experiment we chose that the cooling system has a low coolant level as an induced failure.

As can be seen in the figure, the equipment has an oil cooler that dissipates the temperature given off by the engine, which can be clearly seen in Circle 1, which is also where the largest temperature range recorded is observed, in addition to the exhaust system. In addition, there is a fault in its thermostats due to the fact that they do not open to the correct temperature (circle 2). Maintaining equipment in this condition could cause catastrophic failures for bearings, connecting rods, crankshaft and monoblock, among others. With the support of thermography we can anticipate possible failure of internal elements that make up an internal combustion engine and avoid corrective maintenance repair costs.
