## Architectural proposal for the rehabilitation and improvement of the houses of the city Yagúl housing unit, Oaxaca

HERNÁNDEZ-RODRÍGUEZ, Miguel Adrián†\*, GÓMEZ-BARRANCO, Heidy and RODRÍGUEZ-SÁNCHEZ, Luz Cecilia

*Universidad Autónoma Benito Juárez de Oaxaca (UABJO), Faculty of Architecture "5 de Mayo", Academic Body "Technology and Sustainability". 5 de Mayo No. 111, Historic Center, Oaxaca, Oax. Mexico. 68000.*

DOI: 10.35429/JAD.2021.14.5.27.36

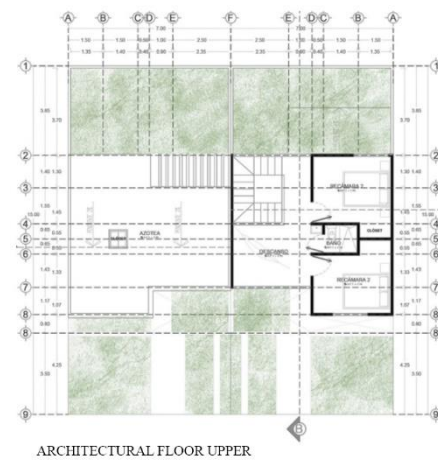
Figure 8 Proposal for the expansion of the upper floor

The house in question has spaces that are too small, so an extension to a second floor is proposed, reorganizing the spaces: on the ground floor a guest bedroom, living room, kitchen and dining room, and on the upper part the addition of 2 bedrooms and a runner.

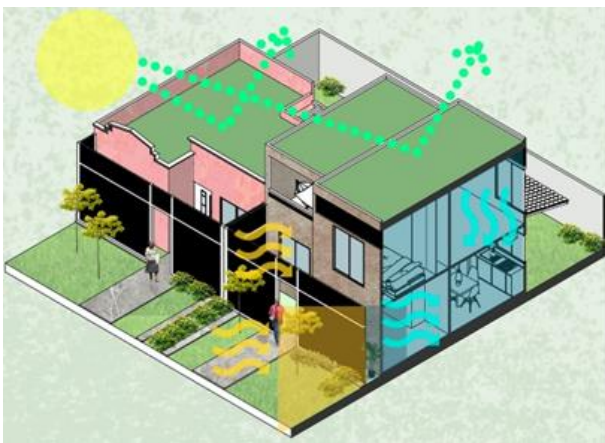
Figure 11 Housing expansion proposal

The lack of space is one of the greatest adversities of the inhabitants, their small size does not allow them good mobility and not being able to have more furniture than the basic one, for this purpose, the expansion of the size of the houses is proposed, on the upper floor leaving more space for the dining room, living room and kitchen and moving the rooms upstairs.

As can be seen in the non-destructive tests carried out on the houses, they are structurally weak, so a structural improvement based on confinement with castles and girders is proposed, which will give us structural security and support for the next improvement mentioned below.

As can be seen in Figure 11, an extension of the house with a second level is proposed, since adaptability is sought for a family of average size; also take advantage of the vertical circulation cube as a nucleus for natural lighting and cross ventilation.

Last but not least, it is intended to include water tanks for the storage of water, since the subdivision lacks planning of this supply and in times of droughts the inhabitants are affected
